# Manhole Inspection Summary

Manhole # S15M\_\_018MH

Insp Date: **3/11/08 10:33 AM**

**Location** Address: **2677 frederick av**

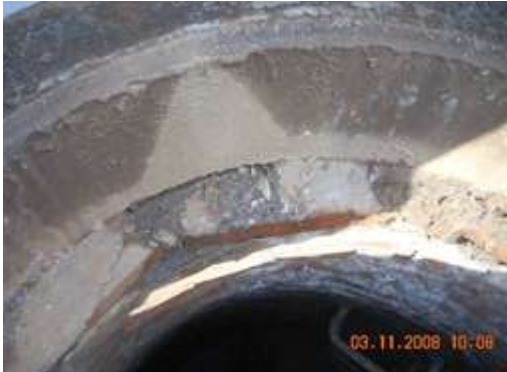
Defect 1

Offset: **2** (in.)

frame offset

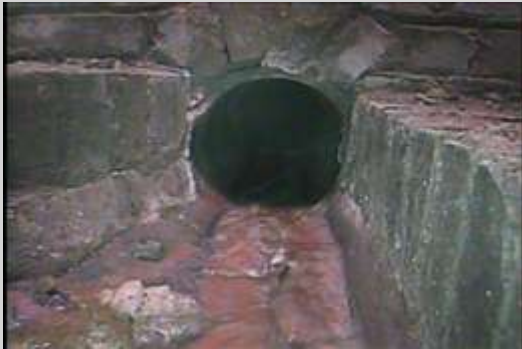
12 O'Clock Outflow

8 in. Circular Gravity Sewer  
Pipe Out @ 12 O'Clock

Pipe Height: **8.4** (in.) Rod and Bar (Angled)  
Pipe Material: **Clay** ☐ Pipe Lined  
Invert Depth: **9.70** (ft.) Flow Characteristics: **Slow**  
Deposits: ☒ None ☐ Mud ☐ Sludge ☐ Debris ☐ Grease  
Silt Depth: **0** (in.) Deposits Extent:  
Infiltration: **None** Pipe Seal Cond: **Sound**

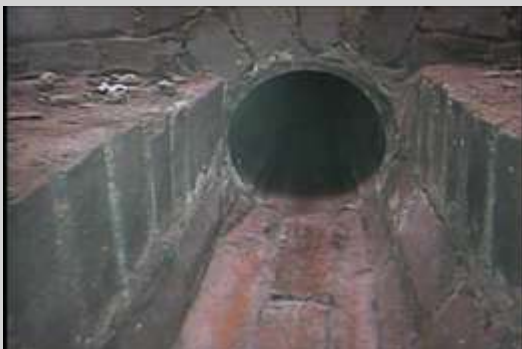
6 O'Clock Inflow

8 in. Circular Gravity Sewer  
Pipe In @ 6 O'Clock

Pipe Height: **8.4** (in.) Rod and Bar (Angled)  
Pipe Material: **Clay** ☐ Pipe Lined  
Invert Depth: **9.56** (ft.) Flow Characteristics: **Slow**  
Deposits: ☒ None ☐ Mud ☐ Sludge ☐ Debris ☐ Grease  
Silt Depth: **0** (in.) Deposits Extent:  
Infiltration: **None** Pipe Seal Cond: **Sound**

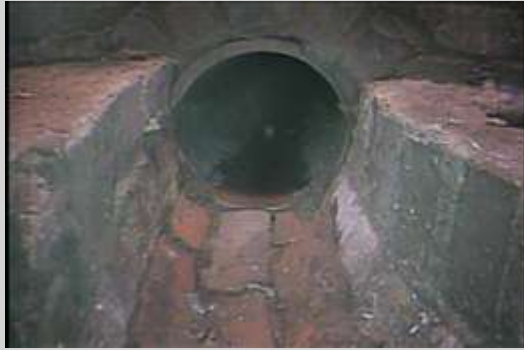
8 O'Clock Inflow

8 in. Circular Gravity Sewer  
Pipe In @ 8 O'Clock

Infiltration: **None** Pipe Seal Cond: **Sound**
